FINAL REPORT Catch Basin Inserts for Ohio Roadways SEPTEMBER 2018

Ohio Department of Transportation Office of Statewide Planning and Research

www.greshamsmith.com GS&P Project No. 42299.00 ODOT PID 103684 State Job No. 135444

Catch Basin Inserts for Ohio Roadways

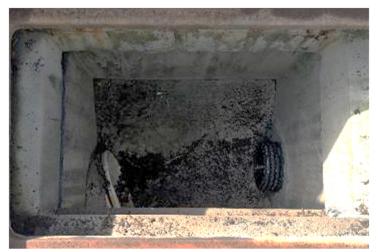
Figure 4-10 Catch Basin Connecting Conduit

- The DrainPac[™] had a very rigid housing, which caused it to impact the connecting conduits or the rim of the concrete catch basin. Installation was possible in only one of the catch basins in the study area.

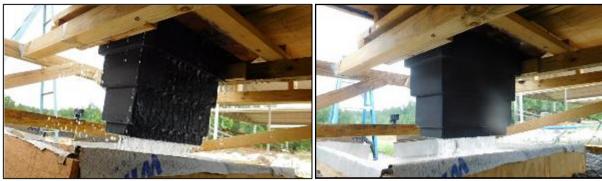
A common issue observed during many of the tests was that a majority of the products allowed water to bypass the treatment material. Many of the products did not fit tightly to the catch basin frame, allowing some influent to bypass the entire product, and hindering treatment potential. Because of this, the testing was modified to the direct discharge method, which forced the influent directly into the CBI, eliminating potential for bypass. Figure 5-8 provides an example of the bypass allowed during sheet flow testing compared to that allowed during direct discharge testing. Figure 5-8(a) shows the water bypassing the CBI by flowing down the outside of the device during sheet flow testing. Figure 5-8(b) shows only water flowing out of the bottom of the device during direct discharge testing. While the WQS is shown as an example, all CBI products except the Triton™ experienced similar issues and had some volume of water bypassing due to the lack of a watertight seal between the CBI frame and the catch basin frame. The bypass volume varied between these units, depending on the CBI's frame and fit, but was not quantified.

(a) sheet flow (b) direct discharge Figure 5-8: Bypass allowed between discharge methods.

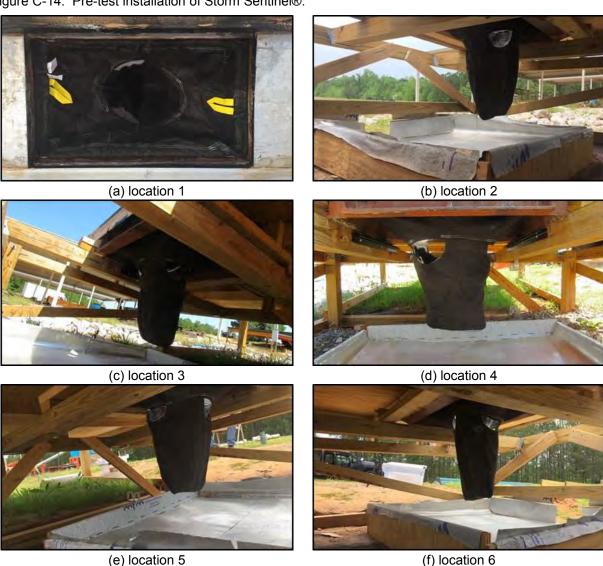
It was observed during the high flow rate tests that the influent flow caused the filter bag to move around the adjustable frame, creating small gaps to open at the entrance to the CBI. The gaps, though small, could allow influent water to bypass the CBI completely and enter the catch basin untreated. The position of the bypass openings also allowed for some flow to directly exit through the openings untreated. These issues can be seen in Figure C-15.

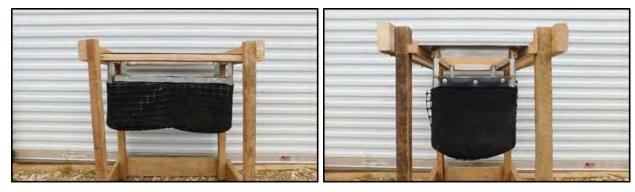
(a) front view (b) side view Figure C-24: Damage to DrainPac™ after eight longevity tests.

A common issue with the DrainPac™ was that many of the products were slightly damaged when shipped to AU-ESCT. When many of the products were removed from their respective shipping boxes, it was found that corners of the frame had been bent, as opposed to lying flat. These bent corners then create gaps between the CBI frame and the inlet frame which allow water to flow past the CBI untreated. Bent edges were attempted to be straightened before installation in order to mitigate the issue. Figure C-4 provides an example of two of the damaged CBIs. All damages are documented in the test reports included in Appendix C of this report.
