FINAL REPORT Catch Basin Inserts for Ohio Roadways SEPTEMBER 2018

Ohio Department of Transportation Office of Statewide Planning and Research

www.greshamsmith.com GS&P Project No. 42299.00 ODOT PID 103684 State Job No. 135444

Catch Basin Inserts for Ohio Roadways

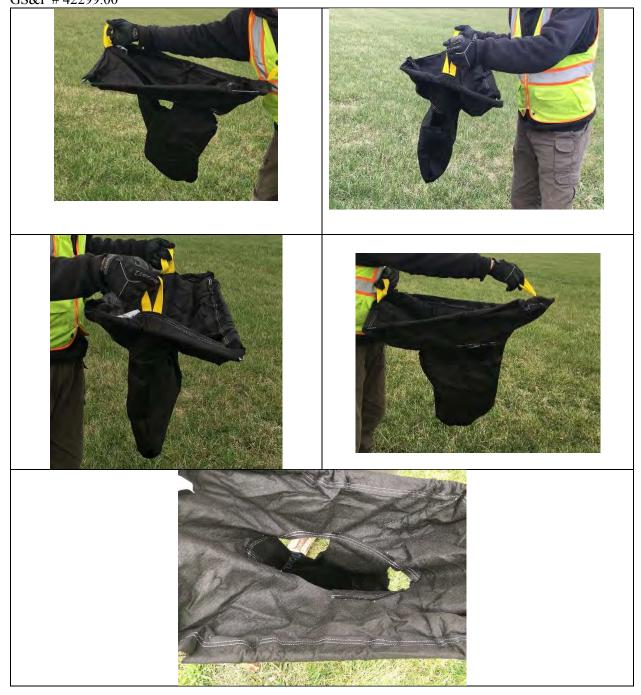
Maintena	nce Form		Weather Information				
Date of	8/23/17	Location		Weather at time of this inspection?				
Maintenance		\boxtimes Site 1 \square Si	te 2	☐ Clear ☐ Rain ☐ Sleet ☐ Snowing				
		101	☐ Other:Sunny during maintenance					
				Temperature:				
Inspector Name(s)	Kathryn Gruv	er						
CDIN	, ,	Γ'		N1				
CBI Name and	Start	Fime End		Number of personnel				
Vendor Storm Sentinel		10:13	2					
Storm Sentinei	10:09	10:13	2					
Observations	- 1	-	Photos					
Describe contents No standing wat Describe condit The block is wo impact flow	tion of throat k	olock						
Describe maint	enance activity	(clean, replace	filter,)					
			d from insert. Les	ss than 1 gallon of material.				
Equipment req	uired for main	tenance						
Any deviation f	from manufact	urer's recomm	endation

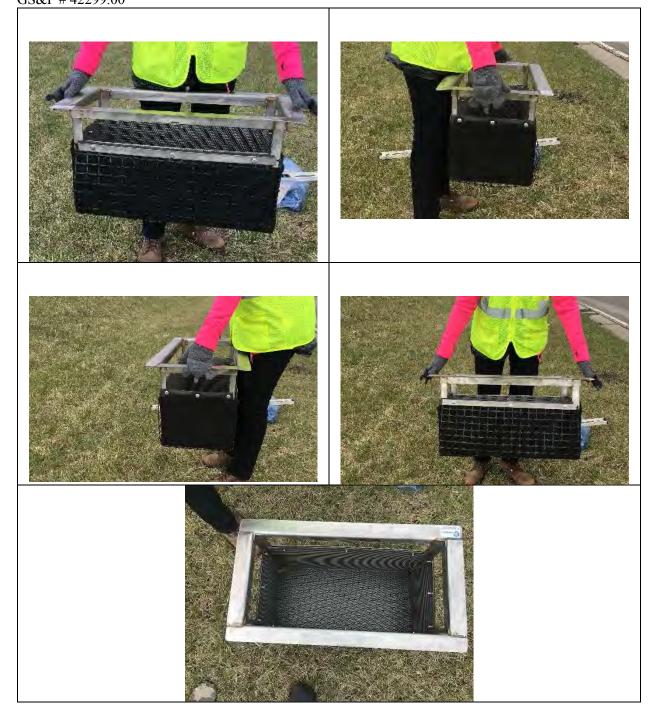
N	Taintenance	Form	Weather Information						
Date of	8/23/	Location	Weather at time of this inspection?						
Maintena nce	a 17	⊠ Site 1 □	☐ Clear ☐ Rain ☐ Sleet ☐ Snowing						
nce		Site 2 104	☐ Other:Sunny during maintenance Temperature:						
Inspector	r Kathry	n Gruver	Temperature.						
Name(s)	i itaan y	ii Giuvei							
CBI	7	Гіте	Number of personnel						
Name									
and Vendor	Start	End							
Drain	10:01	End 10:07	2						
Pac	10.01	10.07							
Observat			Photos						
		d condition							
	basin insert	:							
	ing water.	veen the wire							
	outer fabric								
	n't be remov								
shop vac			A Company of the Comp						
Describe	condition o	f throat block							
The block	k is working.								
			AND A STATE OF THE						
Describe	maintenan	ce activity (clea	n, replace filter,)						
CBI remo	oved from ca	tch basin. 1.5 ga	allons of debris removed from insert.						
			ned, the debris removed from the CBI is consistent with the patching material

Equipme Shop vac	-	for maintenan	ce:						
Shop vac									
Any devi	ation from	manufacturer's	s recommendation

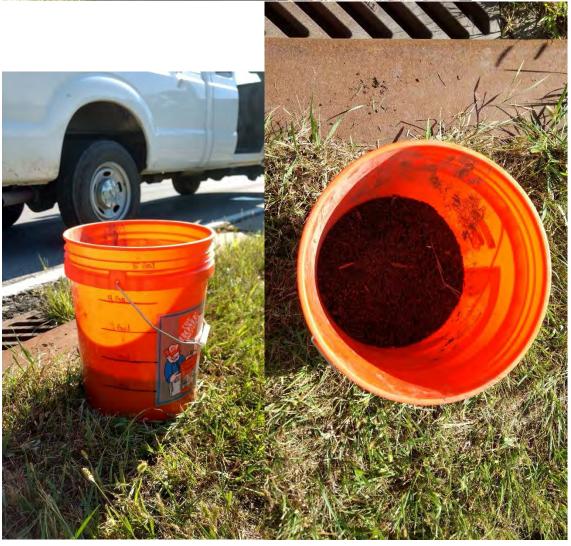
77.1	104	Temperature:						
Inspector Name(s)	Kathry	n Gruver and A	riel Croasman						
CBI]	ime	Number of personnel						
Name									
and Vendor	644	E J							
Venuor Drain	Start 10:47	End 10:54	2 maintananaa tima yaa maagurad anly at tha garaga. It daag not inalyda tima						
Pac	10:47	10:54	2 – maintenance time was measured only at the garage. It does not include time						
1 ac			to remove unit and travel to maintenance area						
Observat			Photos						
		d condition							
	oasin insert	:							
No standi									
		veen the wire							
	outer fabric n't be remov								
shop vac	i t de remov	ed with the							
shop vac									
			All the second s						
			A CONTRACTOR OF THE STATE OF TH						
Describe	condition o	f unit							
		veen the wire	TX III						
	outer fabric								
	i't be remov	ed with the							
shop vac

Back flushing is not a recommended maintenance activity. Unit was clogged during September inspection. The other manufacturers allow back flushing to extend the life of the unit for consistency within the study all clogged units will be back flushed once.

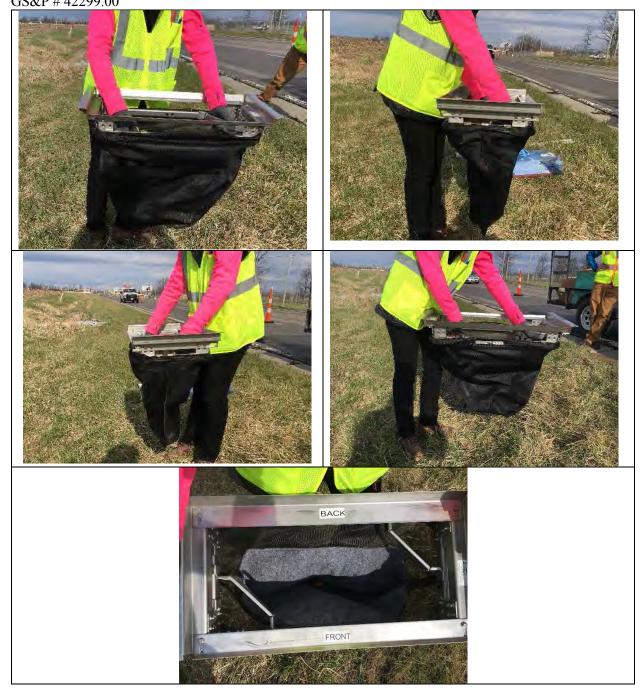
Maintenance	Form	Weather Information					
Date of	8/23/17	Location	Weather at time of this inspection?					
Maintena	a	\boxtimes Site 1 \square	☐ Clear ☐ Rain ☐ Sleet ☐ Snowing					
nce		Site 2	☐ Other:Sunny during maintenance					
		105	Temperature:					
Inspector	r Kathryn G	ruver	•					
Name(s)								
CBI	T	ime	Number of personnel					
Name								
and	G	ъ.						
Vendor	Start	End						
Flex	9:49	9:59	2					
Storm								
Observat	tions		Photos					
Describe	contents and c	ondition of						
catch bas	sin insert:							
No standi	ng water.							
	_							
Describe	condition of th	roat block						
The block	k is working.		(NOS:					
Describe	maintenance a	ctivity (clean, rep	lace filter,)					
CBI not r	emoved from ca	itch basin. Used sl	nop vac and brushes to remove debris. 1 gallon of debris removed from					
insert. Int	ernal overflows	cleaned						
Equinme	nt required for	· maintenance:						
Shop vac

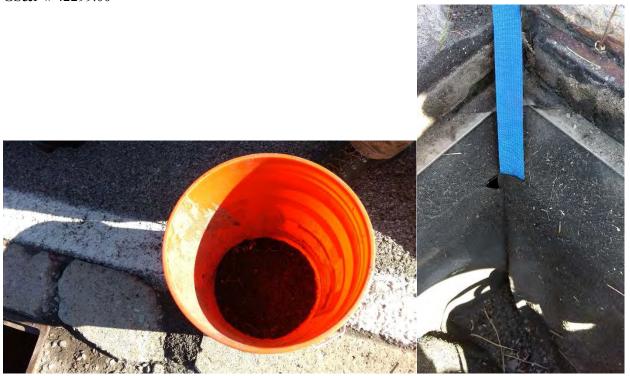
-	W 1 0	109	Temperature:
Inspector	Kathryn G	ruver	
Name(s)			
CBI Name		Time	Number of personnel
and	_		
Vendor	Start	End	
Gully Washer	9:41	9:46	2
w asner			
Observations			Photos
Describe contents and condition of			
catch basin insert:			
No standing water.			
Small rips forming in bag at handles			
Describer and Private College Addition			
Describe condition of throat block			
The block is working.			
The block is working.			The second secon
Describe maintenance activity (clean, replace filter,)			
CDI removed from actab basin. I ass then I callen of debric removed from insert. Internal eventlesses also not			
CBI removed from catch basin. Less than 1 gallon of debris removed from insert. Internal overflows cleaned.			
Equipment required for maintenance:			
Removed CBI and poured contents into collection bucket			
Any deviation from manufacturer's recommendation			
no

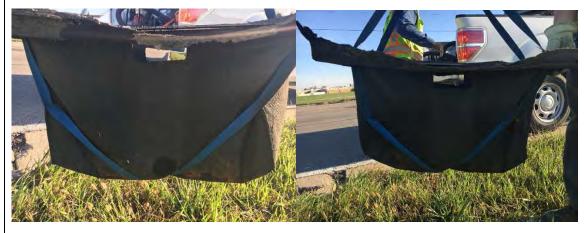
Reason for removal Clogged unit not functional

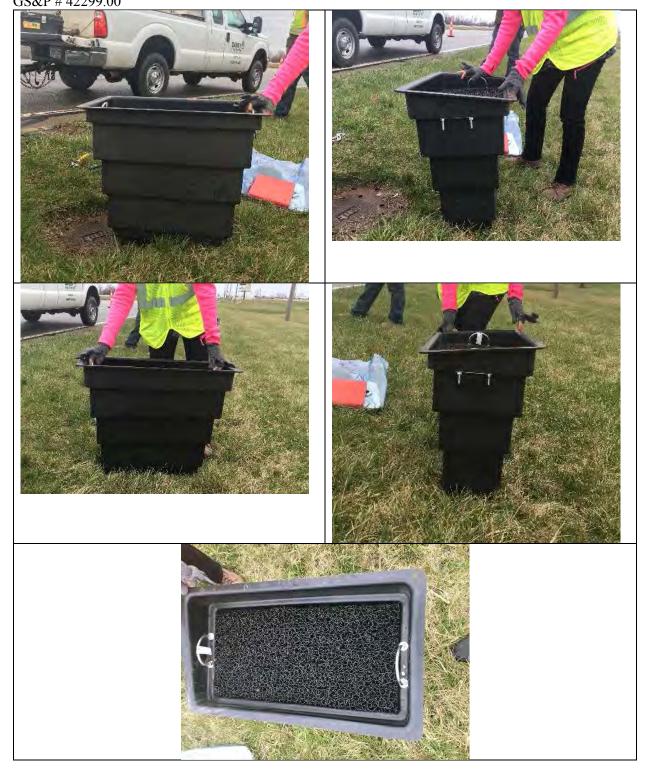
Needed to adjust the handles to not impact the grate. The bolts on the handles were adjusted to let them sit lower into the CBI.

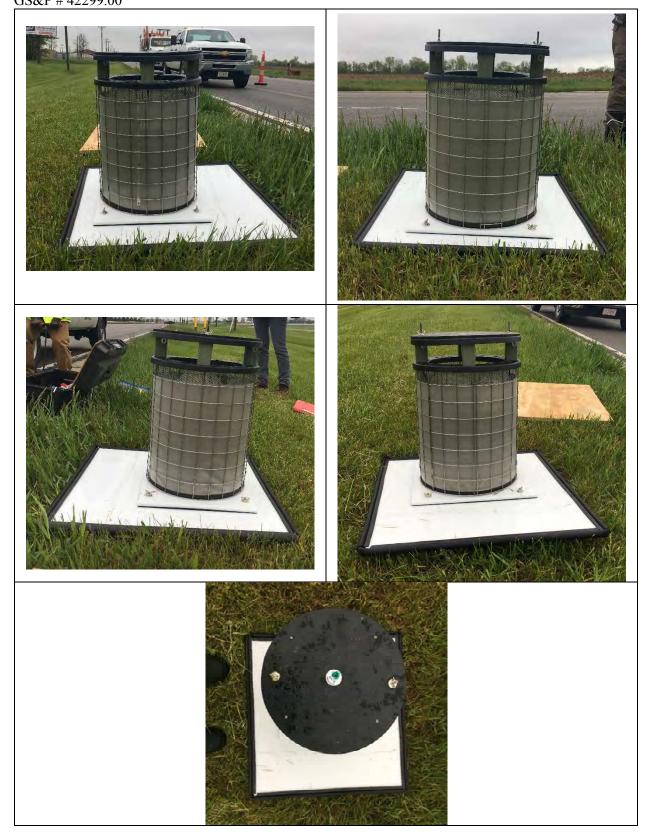
Describe condition of catch basin
Poor condition, concrete around throat is missing. Not expected to impact the flow or performance of unit

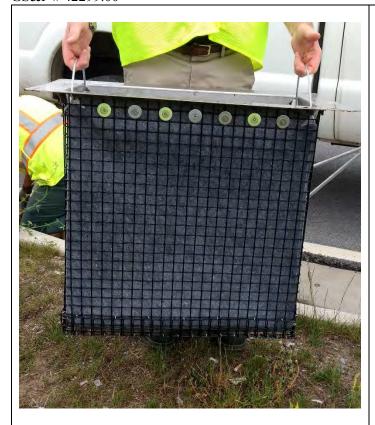
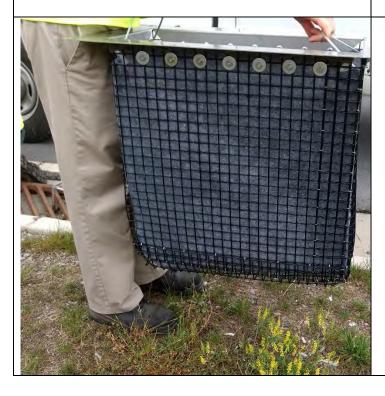
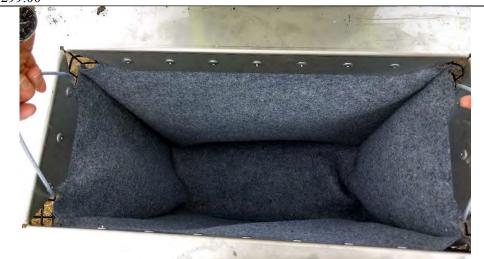
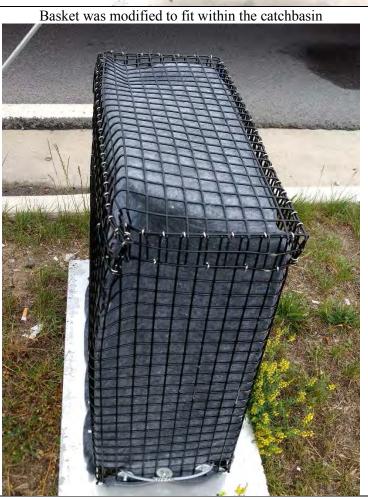
Describe condition of catch basin
Poor condition, concrete around throat is missing. Not expected to impact the flow or performance of unit

Yes, basket shape of basket was modified to within the catch basin

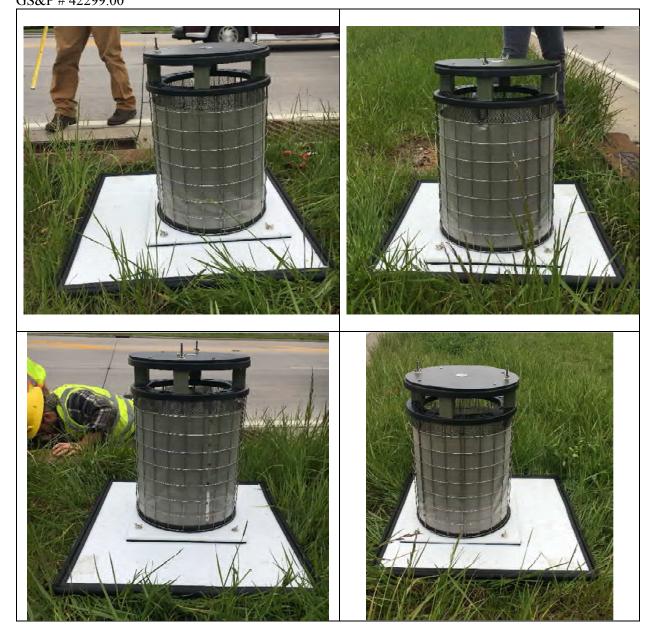
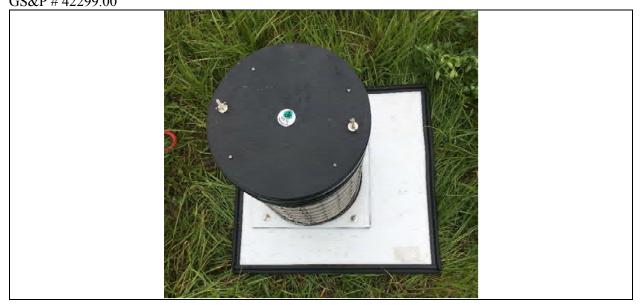
207 Triton™

Very good condition

Top hat location had to be moved closer to the front of the base to allow the unit to be installed within the catch basin. New holes were drilled and the vacated screw holes were filled with spray foam.

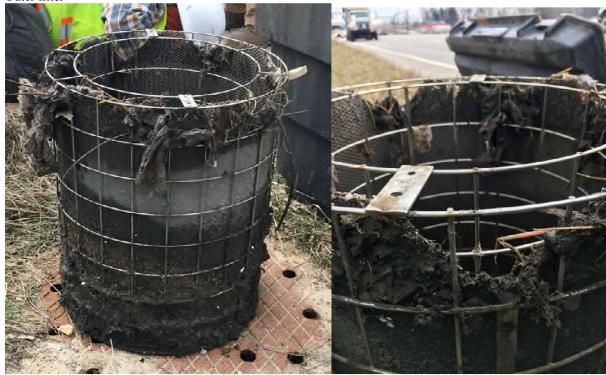
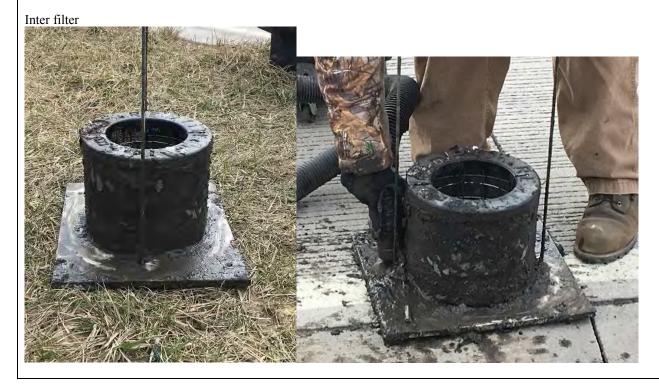
Unit observed with standing water during February inspection and end of study

15 gallons of debris removed, collected in several buckets

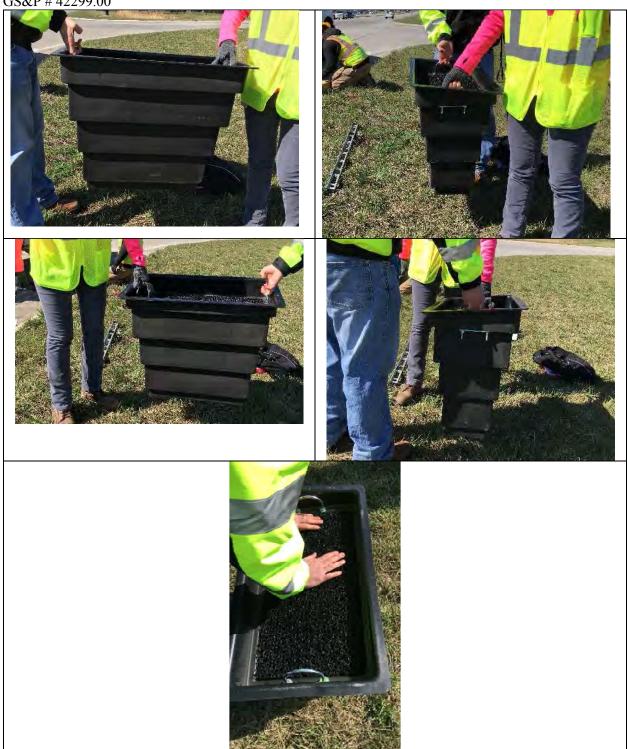
209 WOS

Good condition

Handles are higher than the basket, without modification the grate would sit on the handles. The handles were removed, bent slightly and reattached. The above modification is not expected to impact the performance of the unit.

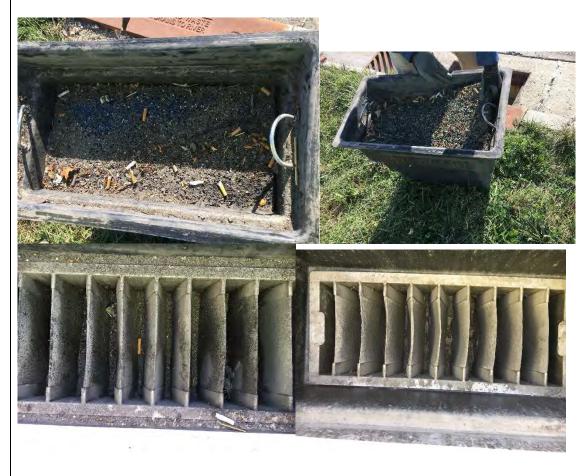
Reason for removal: Standing water during last inspection

Manufacture does not required in field cleaning. The product is to be removed and replaced with a fresh unit. The unit is then cleaned for later reuse.

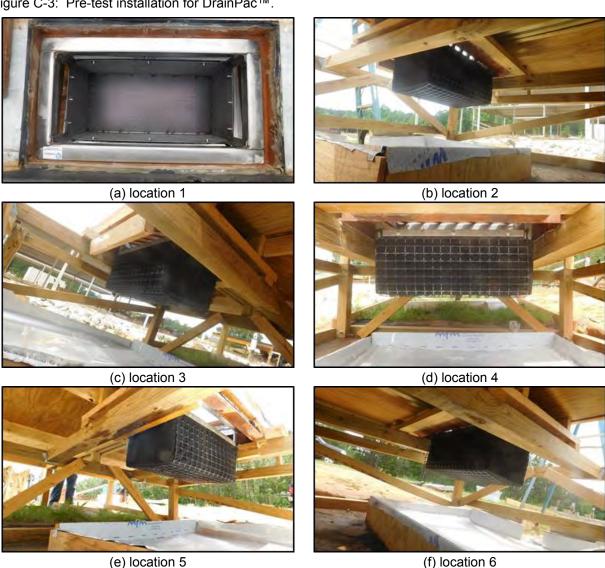
Figure C-3: Pre-test installation for DrainPac™.

A common issue with the DrainPac™ was that many of the products were slightly damaged when shipped to AU-ESCT. When many of the products were removed from their respective shipping boxes, it was found that corners of the frame had been bent, as opposed to lying flat. These bent corners then create gaps between the CBI frame and the inlet frame which allow water to flow past the CBI untreated. Bent edges were attempted to be straightened before installation in order to mitigate the issue. Figure C-4 provides an example of two of the damaged CBIs. All damages are documented in the test reports included in Appendix C of this report.

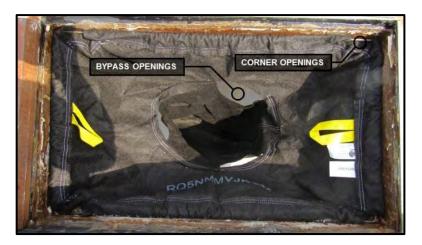
Figure C-15: Openings in Storm Sentinel® allow untreated bypass.

It was observed during the high flow rate tests that the influent flow caused the filter bag to move around the adjustable frame, creating small gaps to open at the entrance to the CBI. The gaps, though small, could allow influent water to bypass the CBI completely and enter the catch basin untreated. The position of the bypass openings also allowed for some flow to directly exit through the openings untreated. These issues can be seen in Figure C-15.

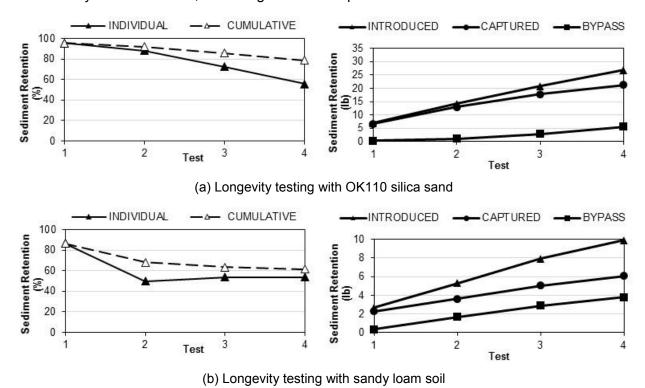
Figure C-22: Sediment retention percentage for Adsorb-It™ over longevity tests.

Table C-9 summarizes longevity data for the Adsorb-It™ when introducing OK110 silica sand and sandy loam. During the L1 test with OK110 silica sand, the Adsorb-It™ retained 95.6% of the introduced sediment, which was similar to the 96.1% sediment retention determined when evaluating the Adsorb-It™ under similar conditions during performance evaluation testing. The Adsorb-It™ was then tested again and retained 88.4% of the sediment introduced during the L2 test, bringing the cumulative retention to 92.0%. An L3 test was conducted with a sediment retention of 72.4% and a cumulative retention of 85.7% across the three tests. While the sediment retention performance for the L3 test was below the 80% rate, the cumulative retention was still well above, so it was determined that the Adsorb-It™ would be tested a fourth time, resulting in an individual retention of 55.7% and a cumulative retention of 78.9% falling below the required threshold, concluding longevity testing.

Figure C-22 shows sediment bypassing increases, or is not being captured at the same rate, over time by the Adsorb-It™, indicating a decline in performance and a need for maintenance.

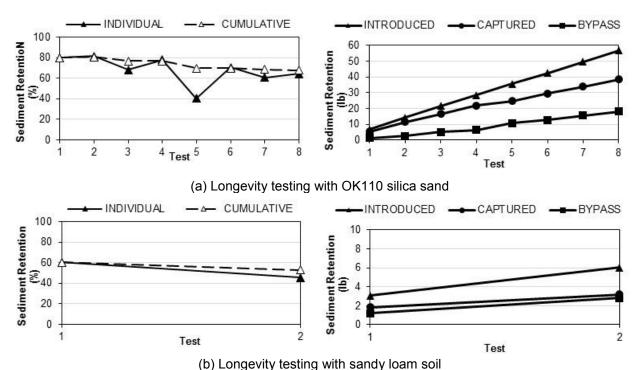
Figure C-23: Sediment retention percentage for DrainPac™ over longevity tests.

Table C-10 summarizes longevity data for the DrainPac[™] when introducing OK110 silica sand and sandy loam. During the L1 test with OK110 silica sand, the DrainPac[™] retained 80.0% of the introduced sediment, which was similar to the 79.8% sediment retention determined when evaluating the Adsorb-It[™] under similar conditions during performance evaluation testing. The DrainPac[™] was then tested again and retained 81.7% of the sediment introduced during the L2 test, bringing the cumulative retention to 80.9%. An L3 test was conducted with a sediment retention of 68.4% and a cumulative retention of 76.7% across the three tests. Sediment retention fluctuated with each test, increasing in retention, decreasing in retention, and continuing. For this reason, longevity testing was expanded to eight tests in order to further observe the pattern and ensure that the DrainPac[™] would not reach the 80% target in another test. After the eighth test, it was determined that longevity testing could be concluded.

Figure C-23 was included to further analyze the DrainPac™ over the longevity tests. Sediment capture rate decreases overtime while bypass increases, indicating a decline in performance and a need for maintenance. Further analysis of Figure C-23 also shows that, while sediment retention appeared volatile when considering the percentages individually for each test, it can be seen that sediment retention is actually fairly linear across all eight tests, with the exception of the one L5 tests, which could be considered an outlier.

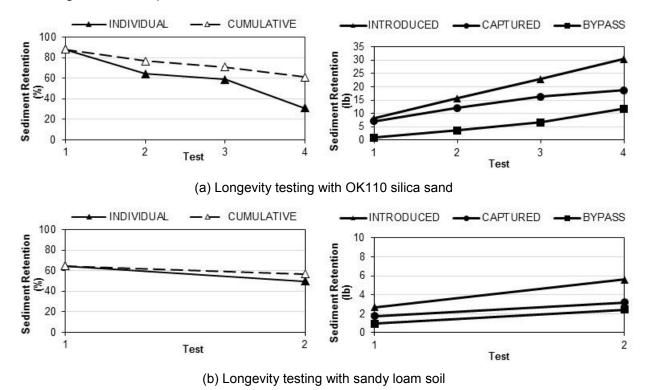
Figure C-25: Sediment retention percentage for FlexStorm® over longevity tests.

Table C-11 summarizes longevity data for the FlexStorm® when introducing OK110 silica sand and sandy loam. Note, test names are abbreviated, whereas L1 is longevity test 1, L2 is longevity test 2 and so on. During the L1 test with OK110 silica sand, the FlexStorm® retained 88.3% of the introduced sediment, which was higher than the 71.3% sediment retention determined when evaluating the FlexStorm® under similar conditions during performance evaluation testing. The FlexStorm® was then tested again, with the 7.17 pounds of sediment collected from the L1 tests still contained within the product and retained 64.5% of the sediment introduced during the L2 test. However, while the 64.5% was below the desired 80% retention, the cumulative retention percentage between the two tests was still at 76.8%. Therefore, it was determined that an L3 test would be conducted, which resulted in a 58.8% sediment retention, and a cumulative retention of 71.1% across the three tests. While the sediment retention performance did decrease from L2 to L3, the decrease was small. Finally, L4 test was conducted to strain the CBI until a significant drop in performance was seen. The FlexStorm® only retained 31.2% of the introduced sediment during the L4 test, leaving the cumulative retention at 61.3%. At this point, it was determined that longevity testing could be concluded.

Figure C-25 further analyzes the FlexStorm® performance over the longevity tests. Notice the difference between the sediment introduced and sediment capture increases with each test, indicating a decline in performance and a need for maintenance.

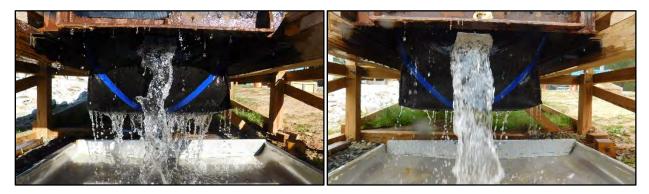
(a) L1 (b) L2 Figure C-26: Gullywasher© during longevity testing with sandy loam soil.

Longevity testing of the Gullywasher© using OK110 silica sand was conducted over three tests. Overflow was reached during the three tests at 24, 7 and 2 minutes, respectively. Longevity testing with sandy loam soil was concluded after two tests, with overflow times of 26 minutes and 1 minute, respectively. The difference in overflow times from L1 to L2 indicate that sandy loam soil severely blinded the fabric after the first tests, inhibiting flow-through rate and causing the CBI to fill to the overflow point very quickly. It can be seen in Figure C-26 that the flow coming through the bypass during the L2 test was much more severe than the flow exiting the bypass during the L1 test.

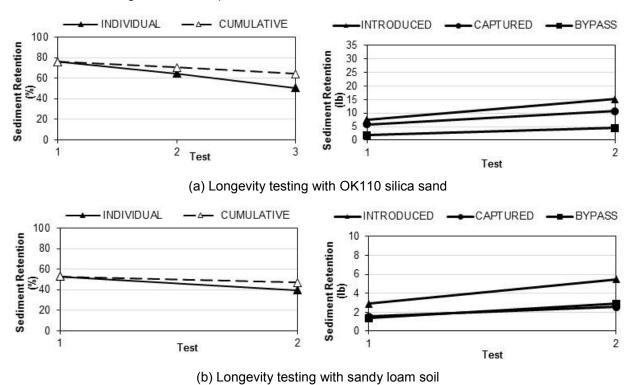
Figure C-27: Sediment retention percentage for Gullywasher© over longevity tests.

Table C-13 summarizes longevity data for the Gullywasher© when introducing OK110 silica sand and sandy loam. During the L1 test with OK110 silica sand, the Gullywasher© retained 75.9% of the introduced sediment, which was similar to, but slightly higher than, the 67.1% sediment retention determined when evaluating the Gullywasher© under similar conditions during performance evaluation testing. The Gullywasher© was then tested again, with the 5.81 pounds of sediment collected from the L1 test and retained 64.9% of the sediment introduced during the L2 test, bringing the cumulative retention to 70.4%. An L3 test was conducted with a sediment retention of 50.8% and a cumulative retention of 64.2% across the three tests. At this point, it was determined that longevity testing could be concluded. While the Gullywasher© never did actually reach the 80% sediment retention target, results from the testing show the potential to perform near this threshold under these testing conditions. However, the longevity data can also be used to conclude that the Gullywasher© would have to be maintained after almost every small storm event in order to continue performance.

Figure C-27 shows the difference between the introduced and captured lines is increasing with each test, indicating a decline in performance and a need for maintenance.

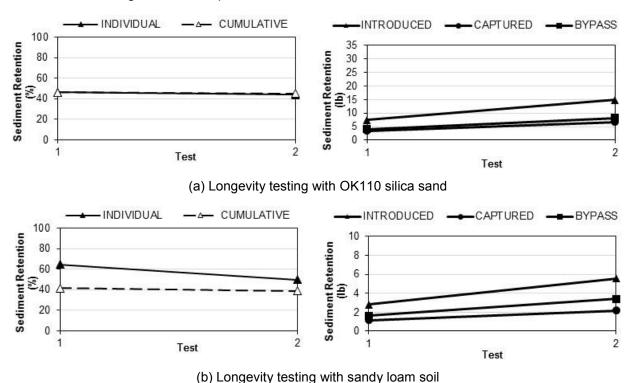
Figure C-28: Sediment retention percentage for Storm Sentinel® over longevity tests.

Table C-14 summarizes longevity data for the Storm Sentinel® when introducing OK110 silica sand and sandy loam. During the L1 test with OK110 silica sand, the Storm Sentinel® retained 46.2% of the introduced sediment, which was lower than the 71.3% sediment retention determined when evaluating the Storm Sentinel® under similar conditions during performance evaluation testing. This difference could be contributed to variations in the product material. The Storm Sentinel® was then tested again, with the 3.43 pounds of sediment collected from the L1 tests and retained 44.1% of the sediment introduced during the L2 test, bringing the cumulative retention to 45.2%. Because there was little difference in performance from L1 to L2, and both tests were well below the 80% target rate longevity testing was concluded. The results from longevity testing show that the Storm Sentinel® is not capable of meeting the 80% sediment removal rate under these testing conditions.

Figure C-28 shows the difference between the introduced and captured lines is increasing with each test, indicating a decline in performance and a need for maintenance.

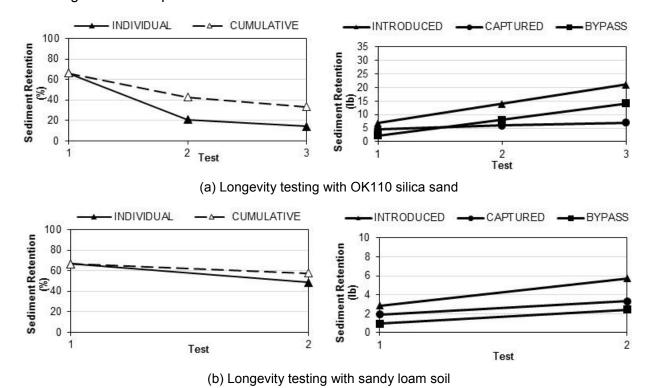
Figure C-30: Sediment retention percentage for Triton™ over longevity tests.

Table C-15 summarizes longevity data for the Triton™ when introducing OK110 silica sand and sandy loam, respectively. During the L1 test with OK110 silica sand, the Triton™ retained 66.2% of the introduced sediment, which was similar to the 68.5% sediment retention determined when evaluating the Triton™ under similar conditions during performance evaluation testing. The Triton™ was then tested again and retained 20.8% of the sediment introduced during the L2 test, bringing the cumulative retention to 42.8%. Results from the longevity testing show that the Triton™ is not capable of meeting performance standards under these testing conditions.

Figure C-30 shows that the amount of sediment bypassing, the Triton™ grows with each test, indicating a decline in performance and a need for maintenance.

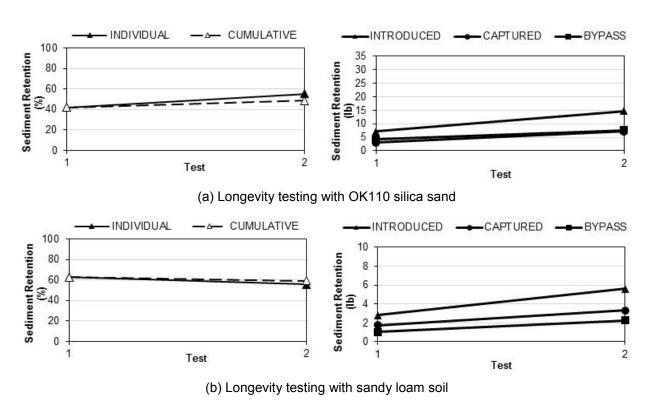
Figure C-31: Sediment retention percentage for WQS over longevity tests.

Table C-16 summarizes longevity data for the WQS when introducing OK110 silica sand and sandy loam. Target sediment introductions for the tests were 7.08 lb for OK110 tests and 2.91 lb for sandy loam tests. During the L1 test with OK110 silica sand, the WQS retained 41.9% of the introduced sediment, which was higher than the 27.1% sediment retention determined when evaluating the WQS under similar conditions during performance evaluation testing. The WQS was then tested again and retained 55.3% of the sediment introduced during the L2 test, bringing the cumulative retention to 48.7%, concluding longevity testing with the OK110 soil. Results from the longevity testing show that the WQS is not capable of reaching the 80% sediment retention rate under the OK110 soil testing conditions. Unlike most other CBIs tested, the WQS actually performed better at the L2 test than at the L1 test. However, it is worth noting that sediment retention actually increased at higher flow rates with the WQS, suggesting that the product performance may benefit from pre-captured sediment.

Figure C-31 shows the distance between the sediment introduction line and the sediment captured line grows greater as testing progresses, indicating a decline in performance and a need for maintenance.

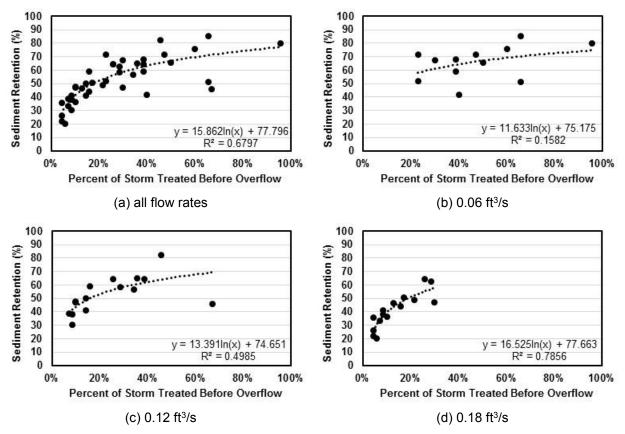
Figure C-41 Comparing overflow to sediment retention

Sediment retention data was also used to analyze the effect overflow events had on CBI performance. Sediment retention data was separated into two categories: (1) tests where overflow does not occur, and (2) tests where overflow does occur. To analyze overflow characteristics, Figure C-41(a) plots sediment retention for CBI products that experienced overflow. Products that did not produce overflow were not included in this analysis since high flow through rates would result in no overflow but also little sediment capture, contradicting the results of this analysis. Each CBI that experience overflow was analyzed by comparing the percent of the storm that was treated before overflow occurs. This illustrates the relationship between overflow and sediment retention values. For example, if 90% of the storm is treated before overflow occurs, sediment retention is likely to be greater than if only 10% of the storm was treated before overflow begins. The data was then fit with a logarithmic trendline to measure the relationship between the two variables. It can be seen from the coefficient of determination that there is a positive, moderately strong correlation between time at which overflow occurs and sediment retention. This means that tests that lasted longer before allowing overflow were more likely to retain a higher percentage of the introduced sediment. A logarithmic trendline provided the best-fit trendline because, while sediment retention does continue to increase with increase in time before overflow, sediment retention will eventually approach a maximum and begin to plateau. Therefore, if overflow occurs early, one can expect much less sediment to be captured. However, overflow that begins near the end of the event has little impact on sediment retention. From these analyzes, it appears that the best performing product would be one that minimizes flow through the fabric to the point of water impounding to near the point of overflow. However, overflow should be minimal and begin near the end of the storm event, resulting in the largest percent of particle size capture.

Figure C-41 (b-d) contain the same information as Figure C-41(a) but are separated by the flow rate used for testing. It can be seen that there is little correlation between overflow and sediment retention during low flow tests. However, correlation increases with flow rate. One possible explanation for this is that higher flow rates enter the CBI with greater energy, therefore causing re-suspension of captured particles, and hindering sediment retention. At low flow rates, the influent enters the catch basin with less energy and less potential for re-suspension, therefore having little effect on sediment retention.
